Manhole Inspection Summary

Manhole # S55O__006MH

Insp Date: **5/27/08 10:59 AM**

Location Address: **rear 3408 elliott st**

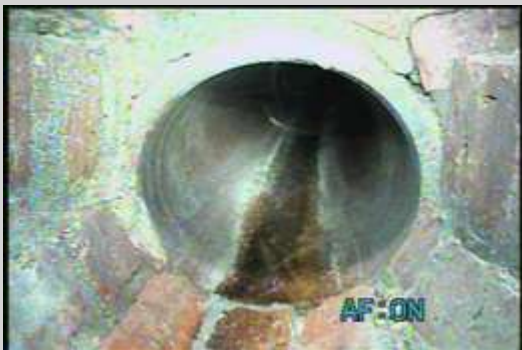
12 O'Clock Outflow

8 in. Circular Gravity Sewer
Pipe Out @ 12 O'Clock

Pipe Material: **Clay** ☐ Pipe Lined

Invert Depth: **8.40** (ft.) Flow Characteristics: **Fast**

Deposits: ☒ None ☐ Mud ☐ Sludge ☐ Debris ☐ Grease

Infiltration: **None** Pipe Seal Cond: **Unknown**

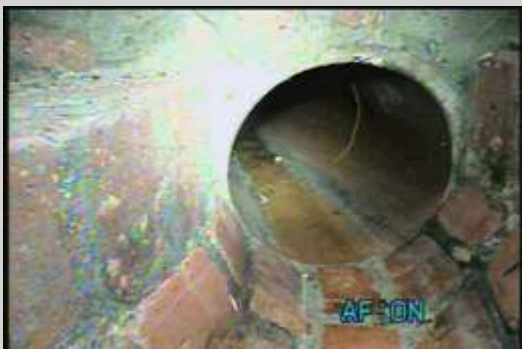
3 O'Clock Inflow

8 in. Circular Gravity Sewer
Pipe In @ 3 O'Clock

Pipe Material: **Clay** ☐ Pipe Lined

Invert Depth: **8.26** (ft.) Flow Characteristics: **Fast**

Deposits: ☒ None ☐ Mud ☐ Sludge ☐ Debris ☐ Grease

Infiltration: **None** Pipe Seal Cond: **Unknown**

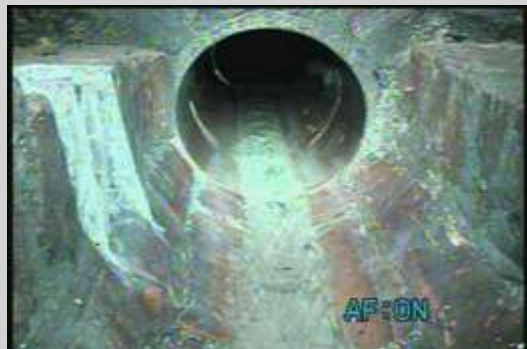
6 O'Clock Inflow

8 in. Circular Gravity Sewer
Pipe In @ 6 OClock

Pipe Material: **Clay** ☐ Pipe Lined

Invert Depth: **8.25** (ft.) Flow Characteristics: **Fast**

Deposits: ☒ None ☐ Mud ☐ Sludge ☐ Debris ☐ Grease

Infiltration: **None** Pipe Seal Cond: **Unknown**
